# **Trip Report**

## **2003 Annual Inspection of the Parkersburg, West Virginia, Nuclear Waste Policy Act Section 151(c) Disposal Site**

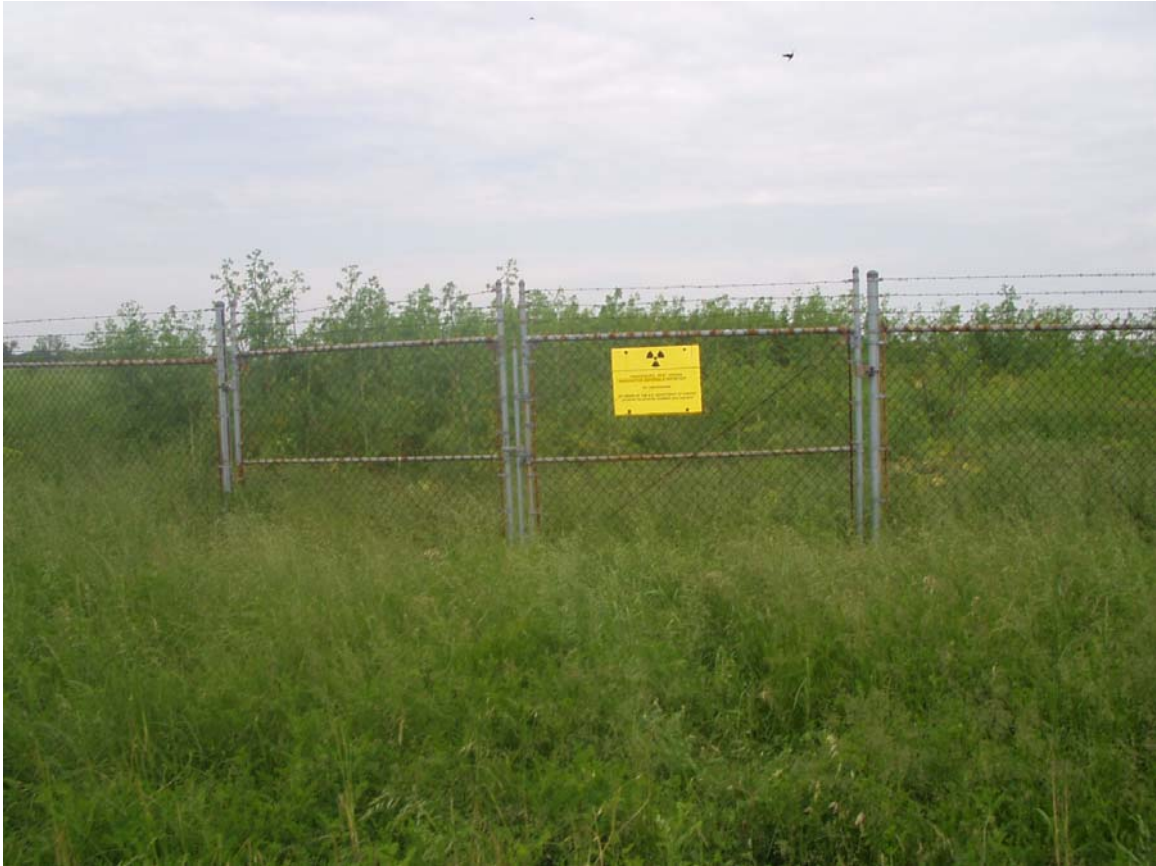
A local subcontractor visited the site in June 2003 to conduct the annual mowing and found poison hemlock (*Conium maculatum*) up to 10 feet high covering 3.8 acres on and near the site (PL-1). This biennial weed is not a listed noxious species in West Virginia; however, it poses a safety hazard to personnel who must walk through or work within infested areas, as all plant parts are poisonous. *Skin contact with this plant should be avoided.* Poison hemlock poses a particular hazard to children, who often play in the soccer fields adjacent to the site. The plant reproduces by seed only and may be effectively controlled with a regular mowing program. It also may be effectively controlled with herbicides, particularly if the plant is sprayed in the rosette stage in the fall or early spring. One insect, the poison hemlock moth (*Agonopterix alstroemeriana*) has been considered for use as a biological control agent for this plant, but its effectiveness is not yet fully known. In July 2003, the LTS&M Program subcontracted to remove the hemlock, which consisted of spraying the plants with herbicide, cutting the plants, removing the root mass, and reseeded. Viable seed remained from the hemlock, and new growth was found in August (PL-2 and PL-3). The eradication process was repeated for the 3.8 acres on the cell cover at that time. In late October, inspectors found other areas, approximately 2 acres in extent, within the fence that were

PKB 10/2003. PL-1. Poison hemlock before cutting and spraying.

**Recommendation:** Contingent upon DOE approval, in 2004, the LTS&M Program will retain a local subcontractor to make frequent visits to the site and to mow the vegetation before undesirable species produce seed. Spot spraying of undesirable plants may be necessary to complete their eradication. The subcontractor's scope will include cutting woody briar-like vegetation between the north fence line and the property boundary so the extent of Canada thistle can be determined and treated as necessary. The subcontractor also shall mow vegetation along the outside of the fence.

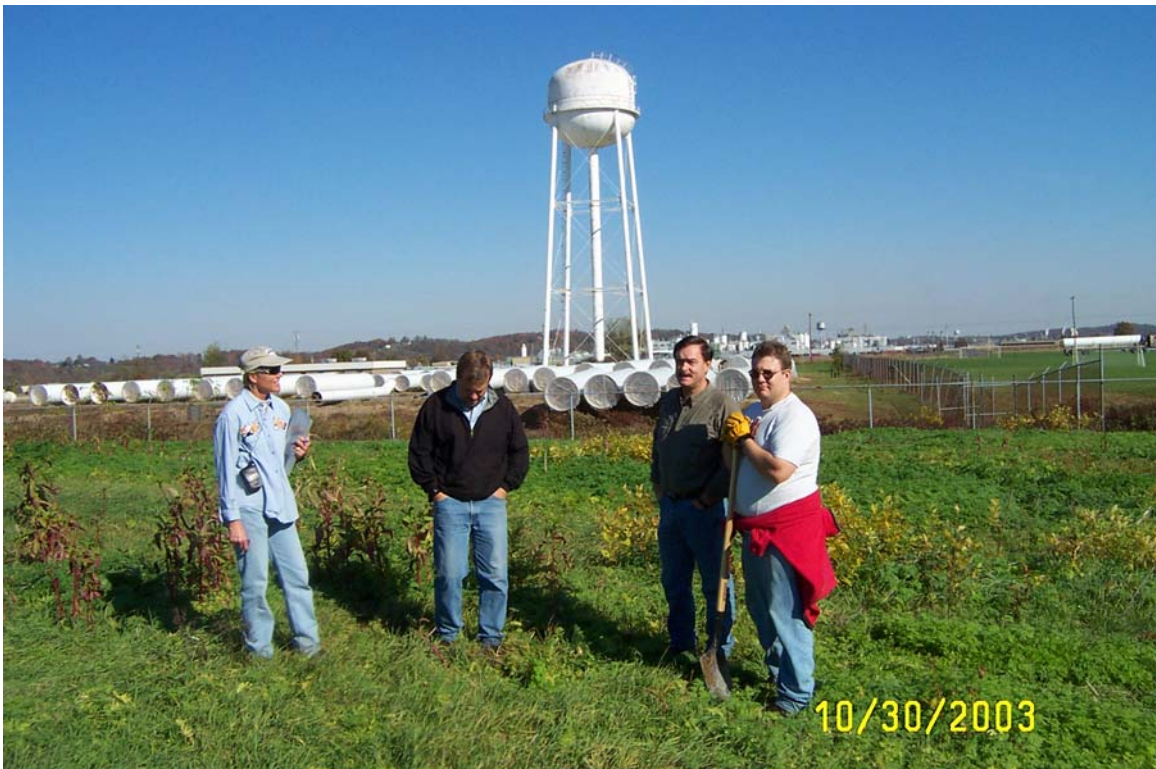
largely devoid of turf species, having instead barren patches of soil and weeds consisting predominantly of poison hemlock. These areas were sprayed, cut, and overseeded in November 2003.

PKB 10/2003. PL-2. Poison hemlock.

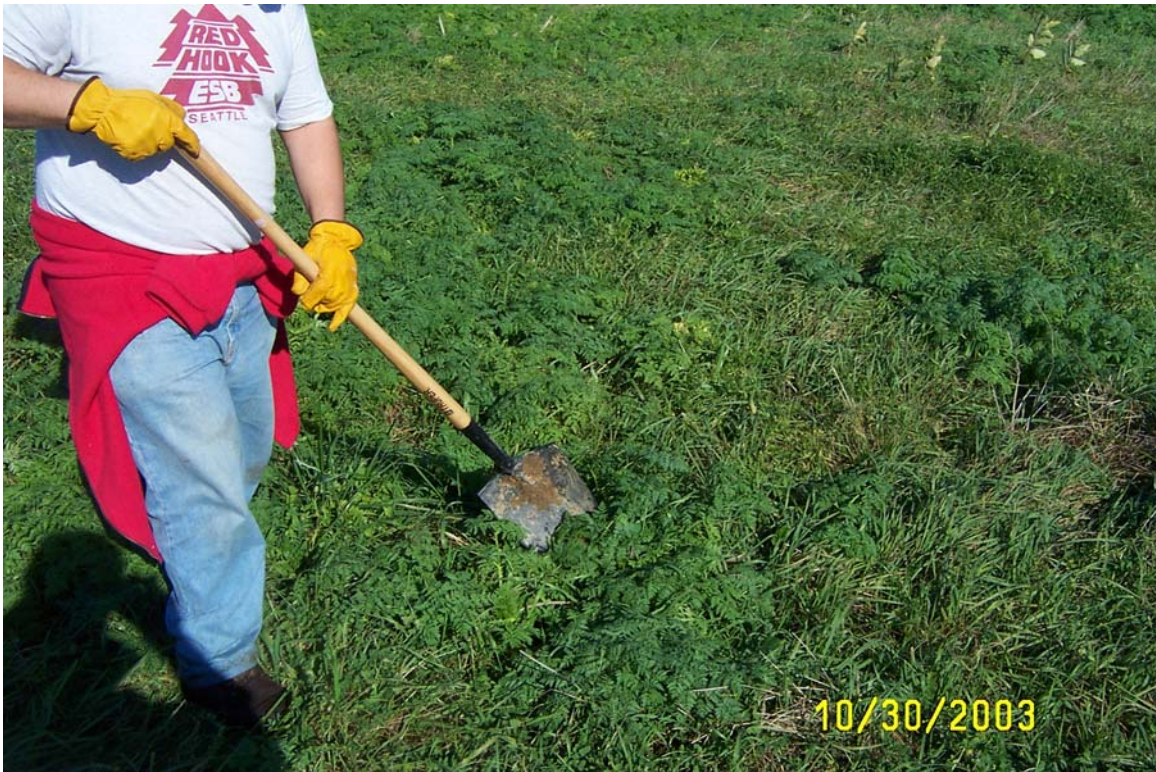
PKB 10/2003. PL-3. Poison hemlock.

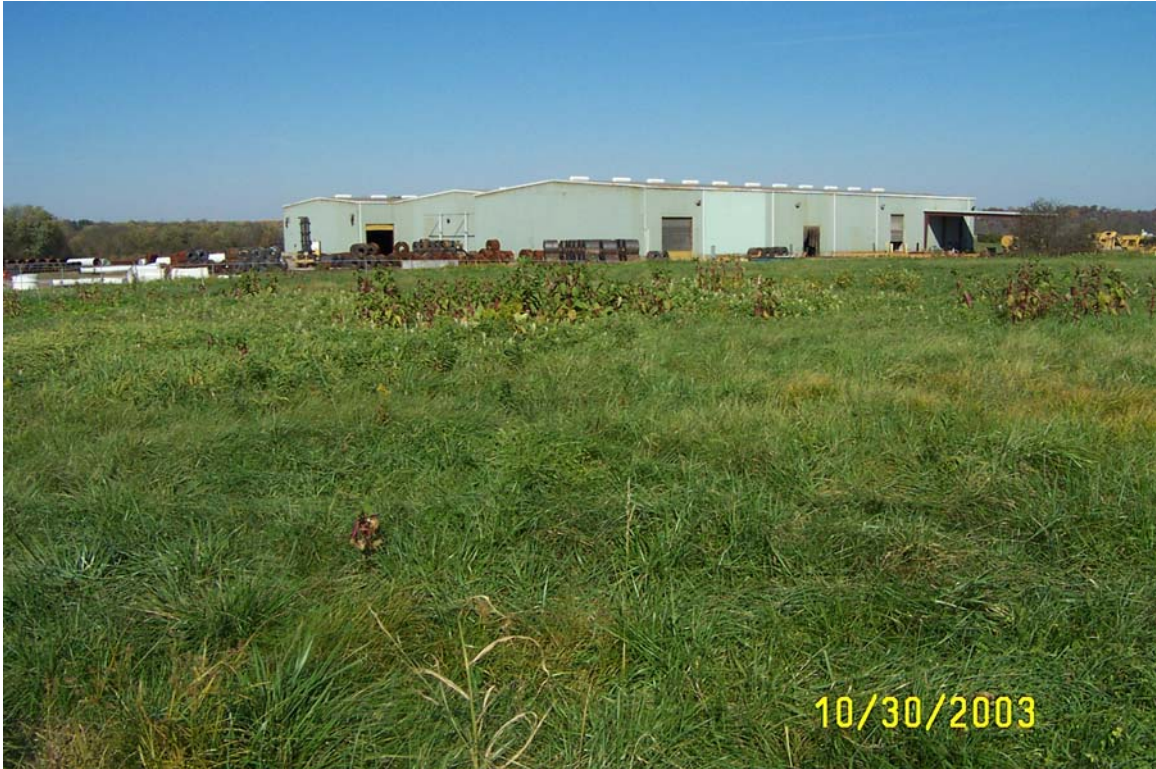
PKB 10/2003. PL-5. Turf on disposal cell cover.

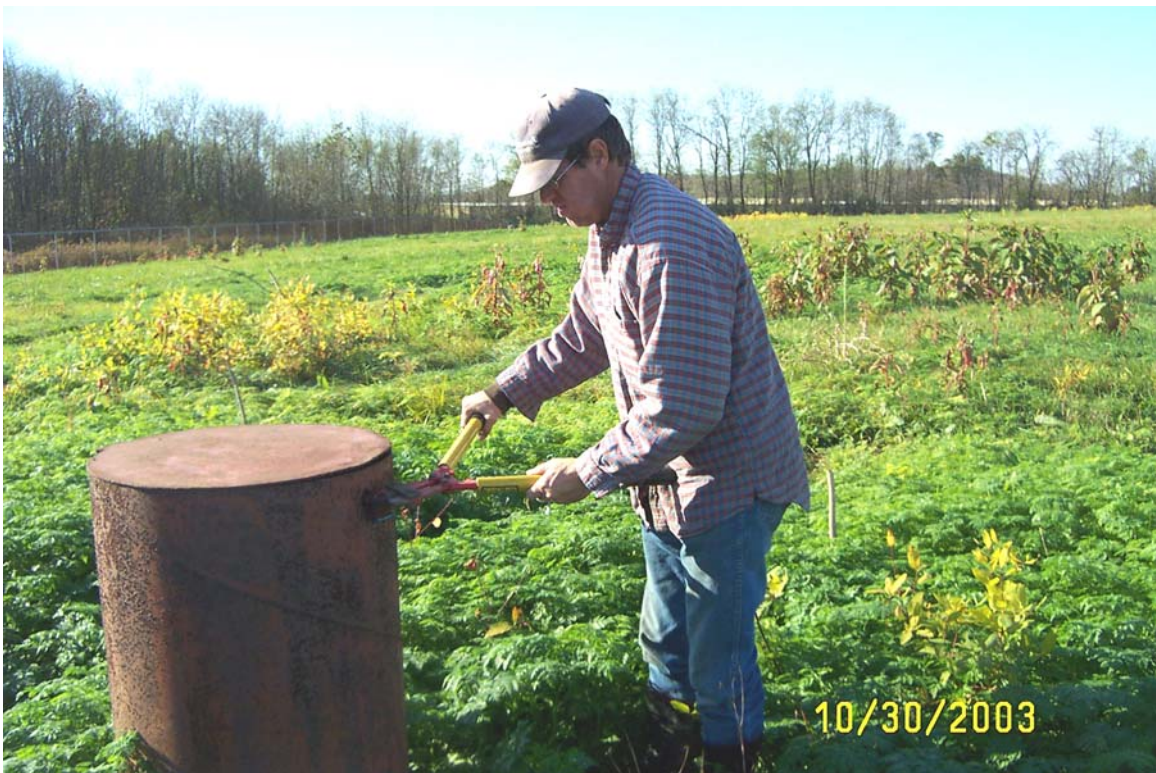
The condition of the six monitor wells inside the fence is unchanged. Monitor wells MW-5 and MW-6, installed by DOE in 1994, are in excellent condition. The casings on the four AMAX wells (MW-1 through MW-4) were rusted, and corroded padlocks were inoperable. Ground water samplers replaced the padlocks (PL-6).

2. Most of the padlocks on the entrance gate, personnel gates, and monitor wells are heavily rusted. These padlocks may be inoperable during future site visits (pages 2 and 3).

PKB 10/2003. PL-6. Replacing the padlock on monitor well MW-1. Note poison hemlock.

**Recommendation:** Inspectors will be prepared to cut rusted padlocks and/or chain and replace with new equipment during future site visits.

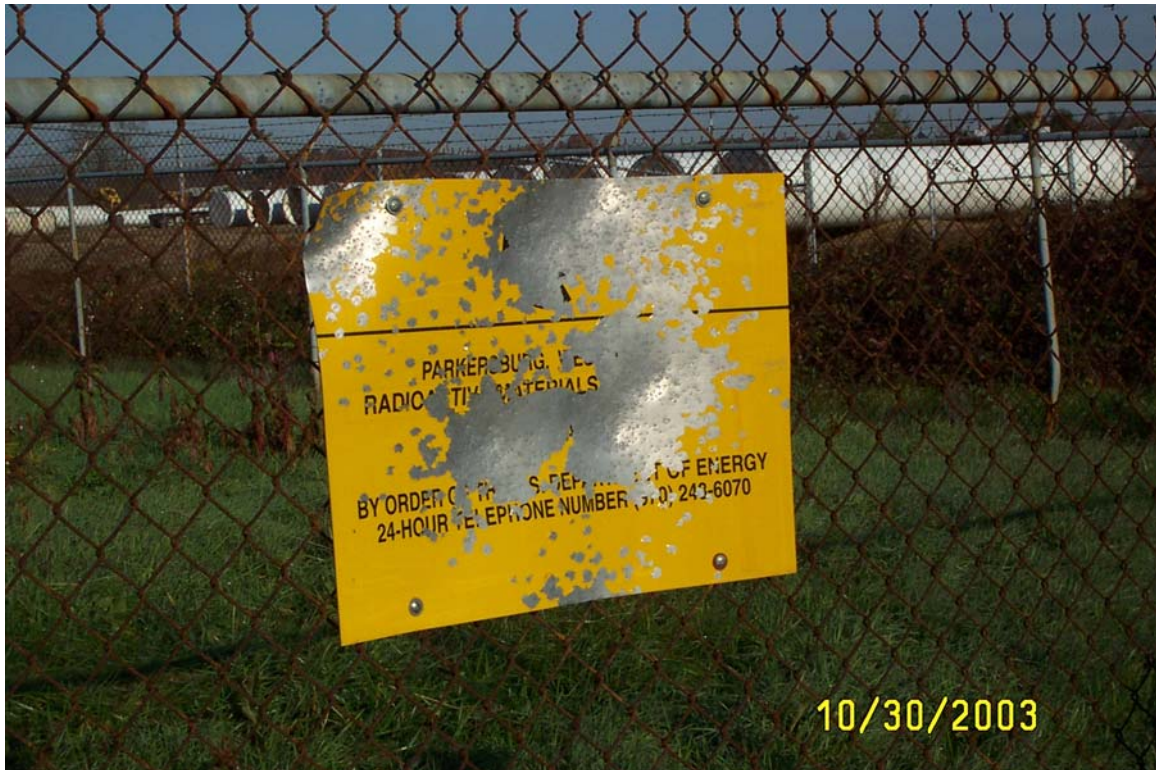
With one exception, perimeter signs are in good condition. Perimeter sign P1 was destroyed by shotgun blasts (PL-7). The LTS&M Program will send a replacement sign to the local subcontractor to be installed. Adhesive overlays with the correct description of the cell contents were applied to perimeter signs in 2001. These remain in good condition.

3. Perimeter sign P1 was destroyed by shotgun blasts (page 2).

PKB 10/2003. PL-7. Perimeter Sign P1.

**Recommendation:** The LTS&M Program will send a replacement sign to the local subcontractor to be installed.

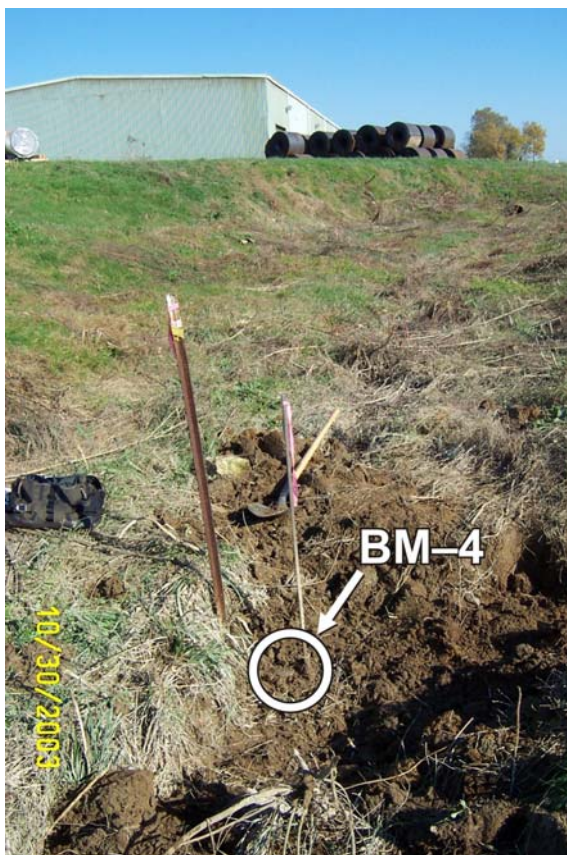
Inspectors could not find boundary monument BM-4 during the 2000 or 2001 site inspections. This monument is in the bottom of a drainage ditch that parallels the northern property boundary. In 2002, a local surveyor located BM-4 beneath more than 4 inches of sediment. In 2003, inspectors again uncovered the monument (PL-8). Inspectors measured the distance between the monument and the fence at two locations so the monument can be located in the field by triangulation. Measuring points are at the second fencepost on either side of the larger fence corner post nearest the monument. This information was added to the inspection drawing. All other boundary monuments were located and are in excellent condition.

PKB 10/2003. PL-8. Boundary monument BM-4 (left of lath).
